DEPARTMENT OF THE AIR FORCE
HEADQUARTERS AIR FORCE CIVIL ENGINEER SUPPORT AGENCY

SUBJECT: **Engineering Technical Letter (ETL) 02-7: Preventing Concrete Deterioration Under B-1 and F/A-18 Aircraft**

1. Purpose. This ETL details the results of several strategies to mitigate concrete deterioration under B-1 Lancer and F/A-18 Hornet aircraft auxiliary power unit (APU) exhaust ports.

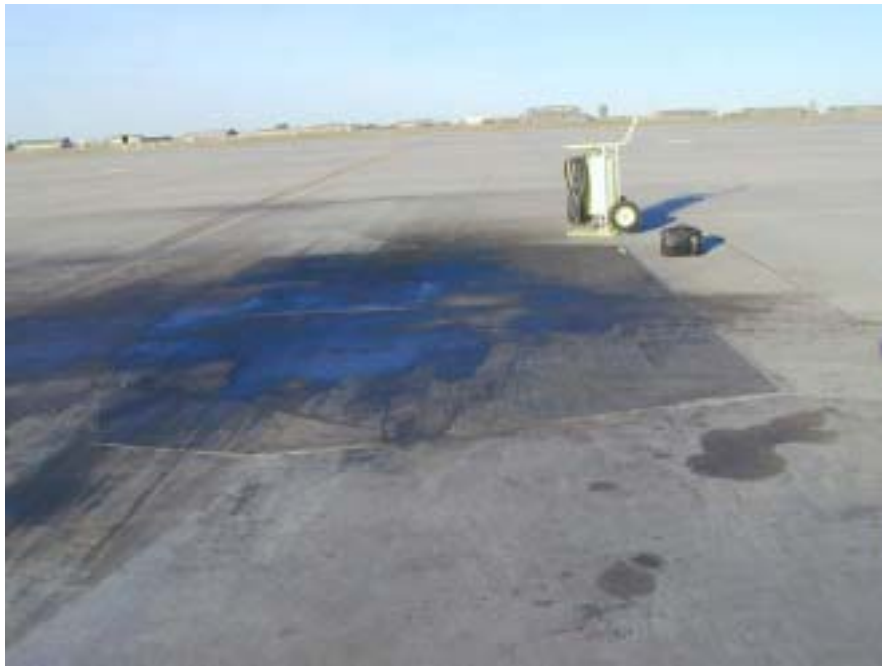
Figure A1.1. Pad B11 Soaked with Hydraulic and Turbine Fluid

A1.1.3. A detailed inspection of the pads was conducted In November 2000. The overall condition of the E-Krete™ was described as “fair.” Approximately 10 to 15 percent of the E-Krete™ surface had delaminated, with severe staining from aircraft fluid. In pads B10 and B12 the E-Krete™ had turned rubbery. This rubbery condition is due to swelling of the polymer within E-Krete™ by JTF. The condition of the E-Krete™ on pad B11 (Figure A1.1) was better than on pads B10 (Figure A1.2) and B12, but some rubbery areas were noted. Despite this condition, the E-Krete™ prevented the aircraft fluids from causing serious damage to the underlying concrete substrate. Given that concrete replacement under the B-1 aircraft generally occurs every two years, the performance of the E-Krete™ coating was considered successful. Delamination of the E-Krete™ occurred from poor adhesion due to existing aircraft fluids already present on

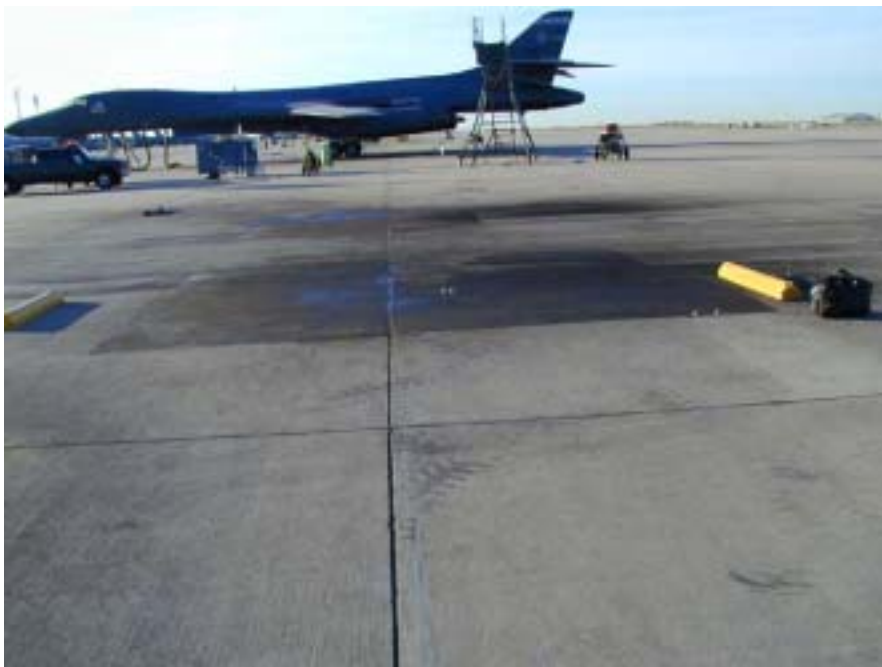
Figure A1.2. Pad B10 Soaked with Hydraulic and Turbine Fluid

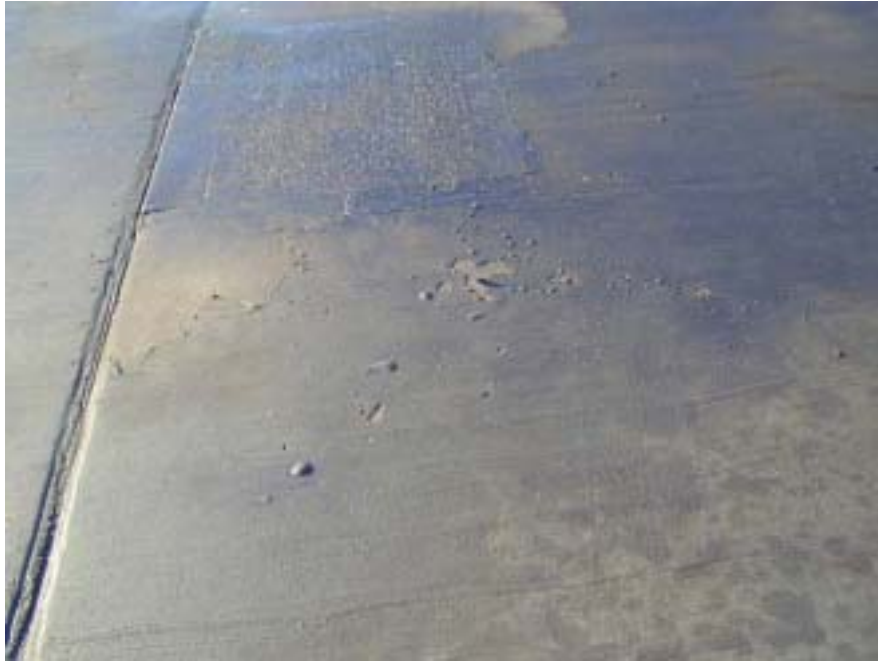
Figure A1.3. Pad B11 Joint, Showing Delamination and Blistering

the concrete and proceeded from the joints towards the center of the concrete slab (Figure A1.3). Further use of the E-Krete™ product is planned at McConnell AFB in 2002.

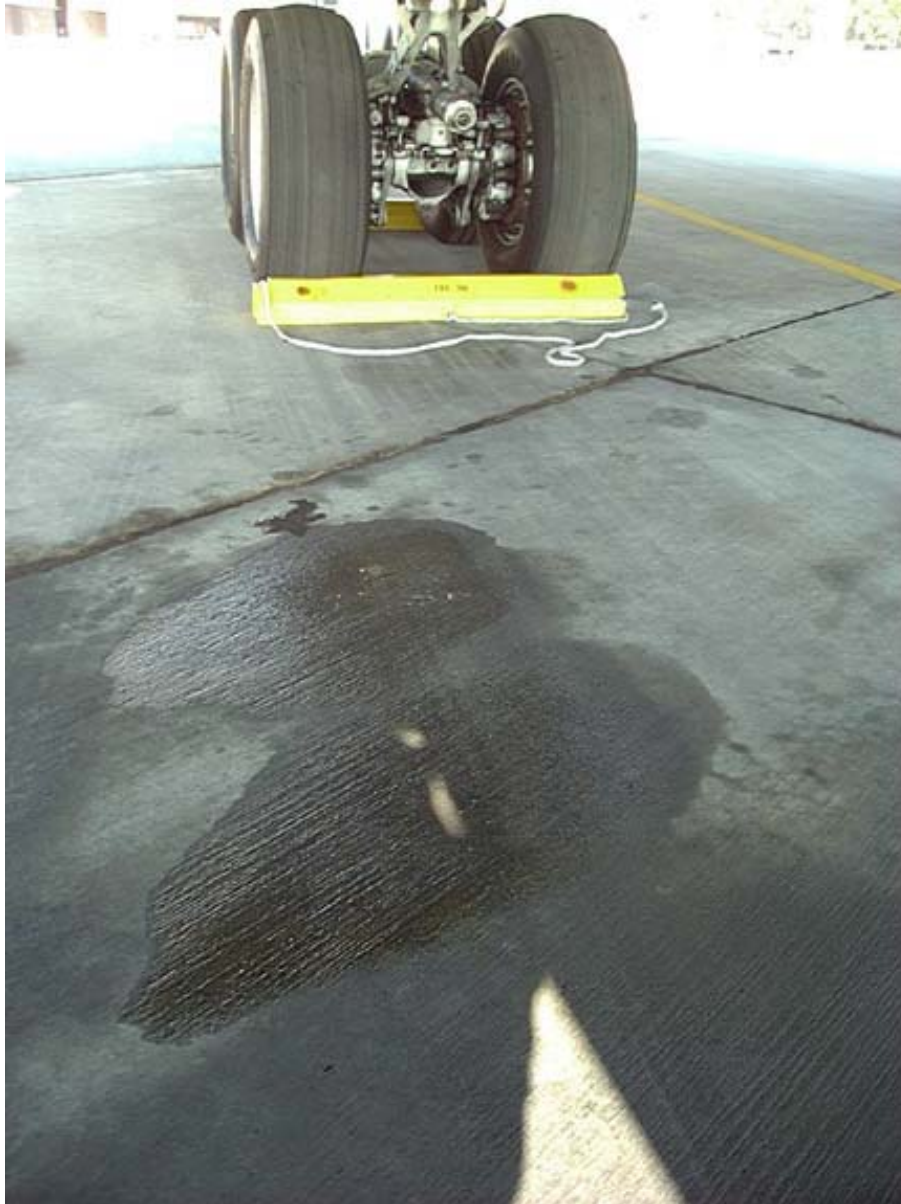
Figure A1.4. Typical Spot Staining

A1.2.1. B-1 Spots. The B-1 aircraft had been parked on this area for eleven months (since September 2000). Most “spots,” as they are referred to at Robins AFB, were in excellent condition; very little cracking was observed. The joint sealants were swollen but appeared to be holding up well, and was reported to be Federal Specification (FS) SS-S-1614, *Sealants, Joint, Jet-Fuel Resistant, Hot-Applied*. Hydraulic fluid was easily spotted due to its red color; JTF and lubricating oils appeared as amber-gold or brown. Leaking JTF under the engines/APU was also apparent (Figure A1.4). There were two different types of concrete in use and one concrete surface treatment: PCC with Georgia limestone aggregate; PCC with Iron Mountain traprock from Missouri; and PCC with Georgia limestone aggregate with Surtreat[®] concrete sealer. No deterioration was noted other than some minor shrinkage cracking (Figure A1.5).

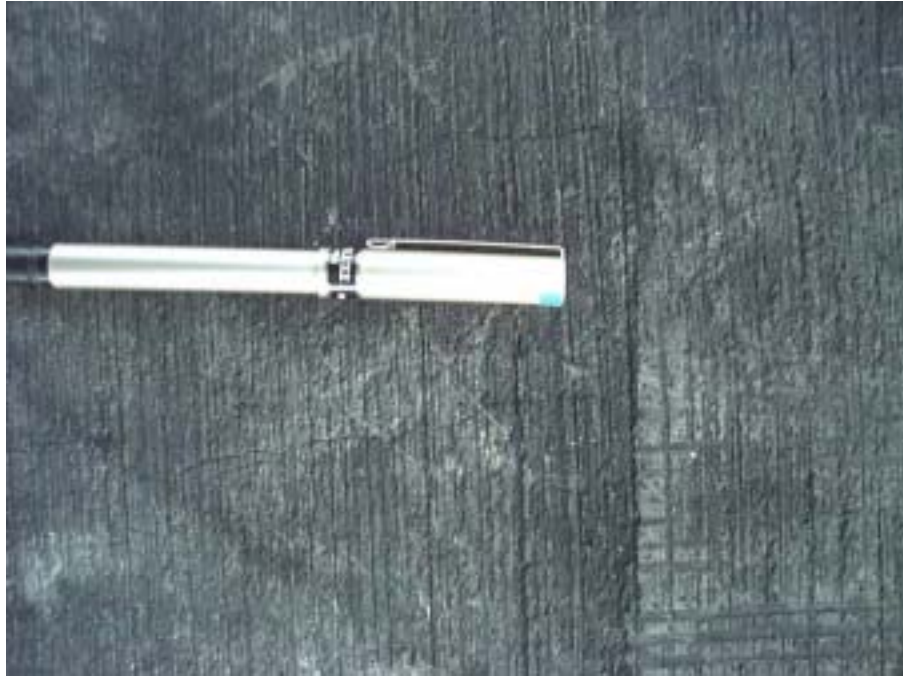
Figure A1.5. Spot 2 Shrinkage Cracks

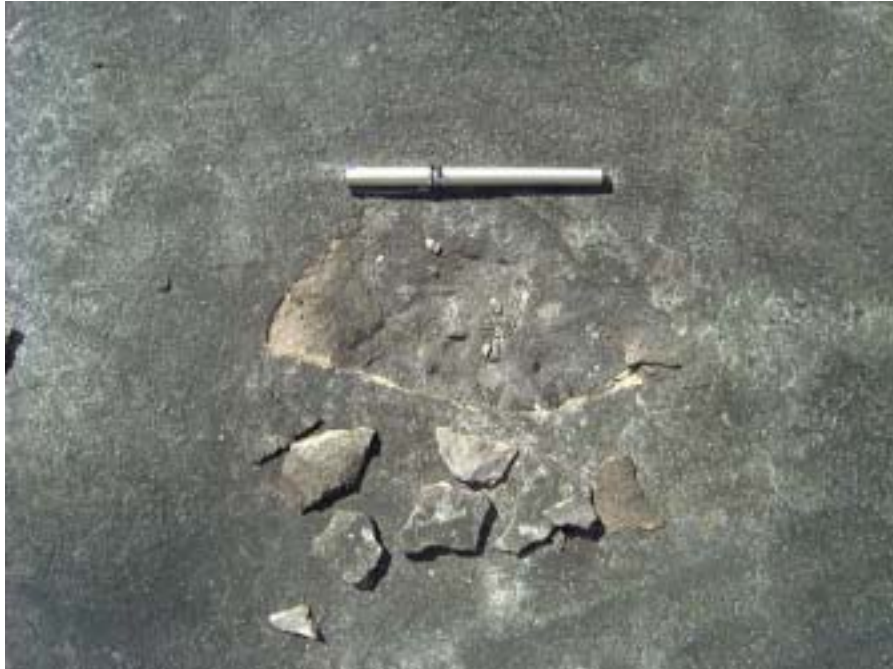
Figure A1.6. Close-up View of Scaling at Old Alert Apron

A1.2.2. Christmas Tree (Old Alert Apron). B-1 aircraft were parked on this apron, composed of 50-year-old concrete, for approximately two years. Some surface cracking in the old concrete was observed but most of the concrete slabs appeared structurally sound. The old concrete had a mottled, moldy surface. Some slabs had obviously been replaced and those showed more damage. The damage was typical of that observed under B-1 aircraft. The damaged concrete exhibited severe scaling and surface concrete paste was delaminating in sheets (Figures A1.6 and A1.7).

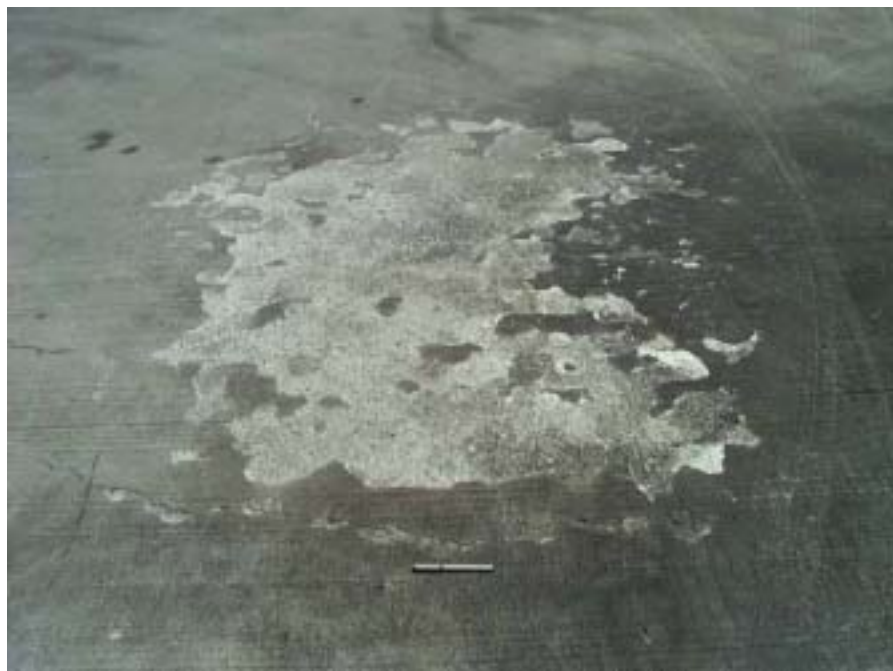
Figure A1.7. Scaling at Old Alert Apron

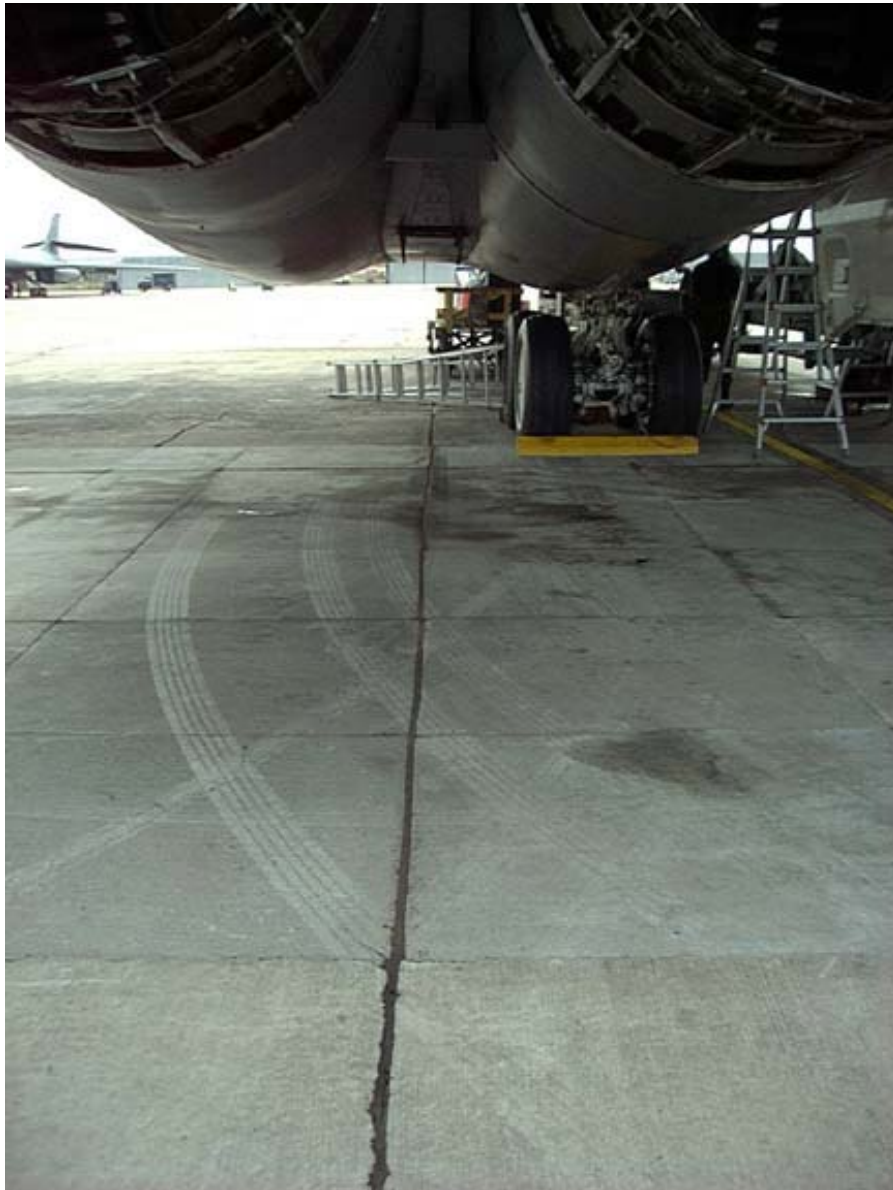
Figure A1.8. MPC “Checkerboard” Repair Area

A1.3.4. The construction of the Set 45™ pads was completed in a checkerboard fashion using slabs no larger than 1.5 meters by 1.5 meters (5 feet by 5 feet) (Figure A1.8). An area approximately 12 meters by 7.5 meters (40 feet by 25 feet) was replaced. The existing concrete was sawcut (where necessary) to a depth of 76 millimeters (3 inches) and the concrete removed with a jackhammer. The prepared surface was then drilled to provide anchors for the forms and the forms were placed. The Set 45™ was then placed in a checkerboard fashion where the “red” squares were filled, the forms removed, and the “black” squares filled using the new Set 45™ slabs and the old concrete as the forms for the second round of Set 45™ placements. A small concrete mixer was employed to mix the Set 45™/basalt mixture. Each form was filled and the surface finished before proceeding to the next form. Some shrinkage cracking

of the Set 45™ slabs was noted but it was not severe.
